# Manhole Inspection Summary

Manhole # S29OO1104MH

Record Plat: **29001** Node: **104** Status: **New Manhole (Not in GIS)** Insp Date: **7/14/07 12:00 AM**

**Location** Address: **ALPINE RD**

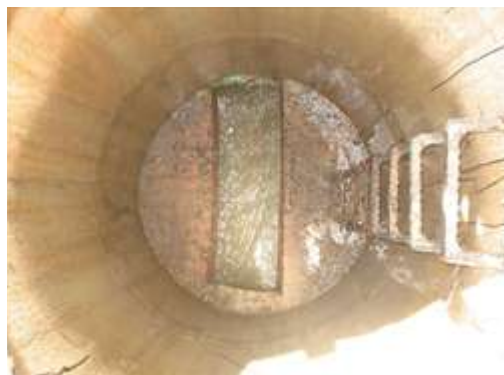
Top View

Adjustment and Barrel infiltration.  
Evidence of surcharge - bench debris.

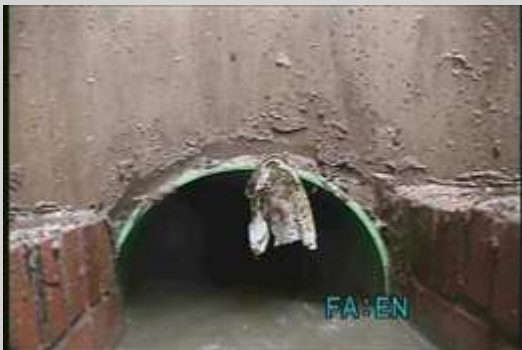
### 15 in. Circular Gravity Sewer Pipe Out @ 12 O'Clock

Deposits: ☒ None ☐ Mud ☐ Sludge ☐ Debris ☐ Grease

Infiltration: **None** Pipe Seal Cond: **Unknown**

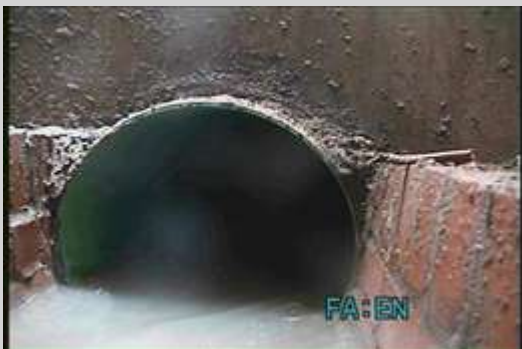
### 15 in. Circular Gravity Sewer Pipe In @ 6 O'Clock

Deposits: ☒ None ☐ Mud ☐ Sludge ☐ Debris ☐ Grease

Infiltration: **None** Pipe Seal Cond: **Unknown**
